## Electrical

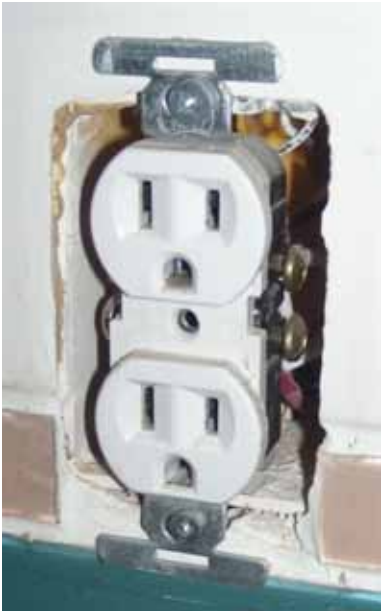
Many of the receptacles tested in the home were found to not be fully functional on first test. Either the contacts were worn or there were wiring shorts present. The inspector found eight receptacles were the electrical circuit tester gave varying results depending on the number of times the receptacle was tested. The cover plate was removed from one receptacle and it was noted that the quick connections on the back of the receptacle have been used to connect electrical wiring. This is a poor practice that can lead to shorting and possible fires. It is recommended that a ticketed electrician be hired to rewire all house receptacles.

Receptacle is "back-wired"

- Hire certified electrician to rewire all receptacles using receptacle terminals instead of quick connections (correct garage reverse polarity receptacle at same time)
- Add GFCI protection to bathroom receptacle in basement and receptacle on rear deck
- Have certified electrician check electrical grounding wire see if replacement is required
- Have certified electrician repair/replace the service entrance conduit
- Have certified electrician relocate exhaust fan switch in main upstairs bathroom
- Have certified electrician provide arc fault protection to bedrooms
- Reattach light fixture in downstairs bedroom closet to electrical box

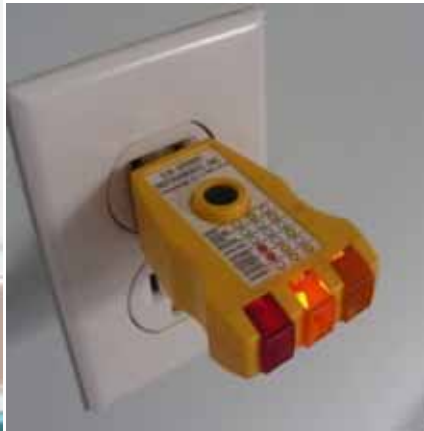
first test shows problem

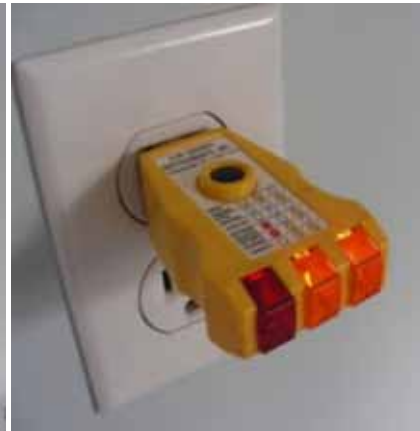
second test on same receptacle shows no problem

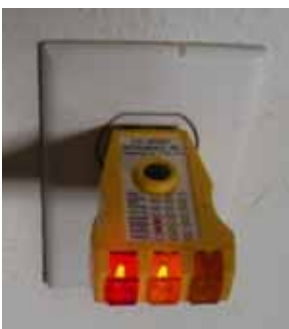
The receptacle in the garage on the north wall had been wired with reversed polarity (black-and-white wire reversed) and should be corrected by qualified electrician as soon as possible. The current condition represents a shock hazard, especially for electrical tools that may be used in a garage in wet conditions.

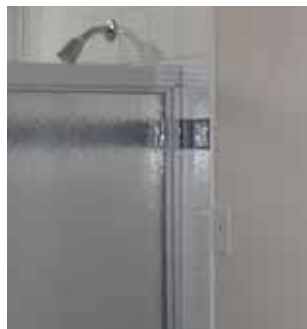
The exhaust fan switch is right beside the shower stall in the upstairs main bathroom and presents a shock hazard (See right photo to left).
